Equipment failures to cost STPUD \$3 mil.

By Kathryn Reed

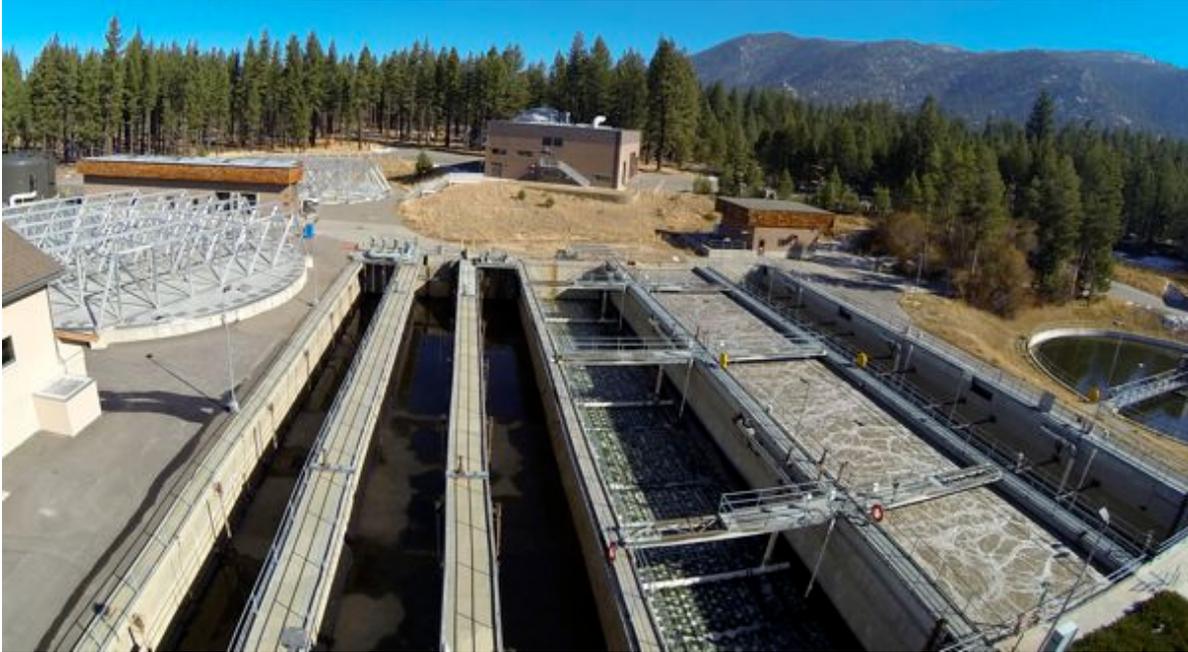
The aeration basin at South Tahoe Public Utility District. Photos/Ross Johnson

“The aeration basins are a critical part of the biological process at the treatment plant,” Sciuto said. “It’s almost like you see bubbling chocolate milk. It’s pretty uniform when you look at the surface of the water. If there is an area with less bubbles, there is probably a failure in the air pipe.”

The air is helping breakdown the organic material. Air is being blown 24/7. Each basin is about 20 feet by 100 feet.

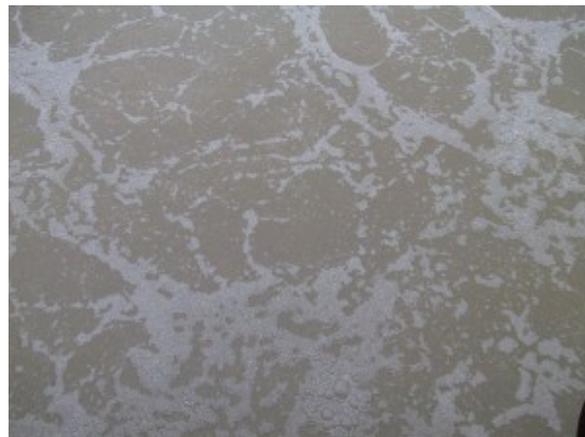
Activated sludge at the sewer plant.
