# Equipment failures to cost STPUD \$3 mil.

## By Kathryn Reed

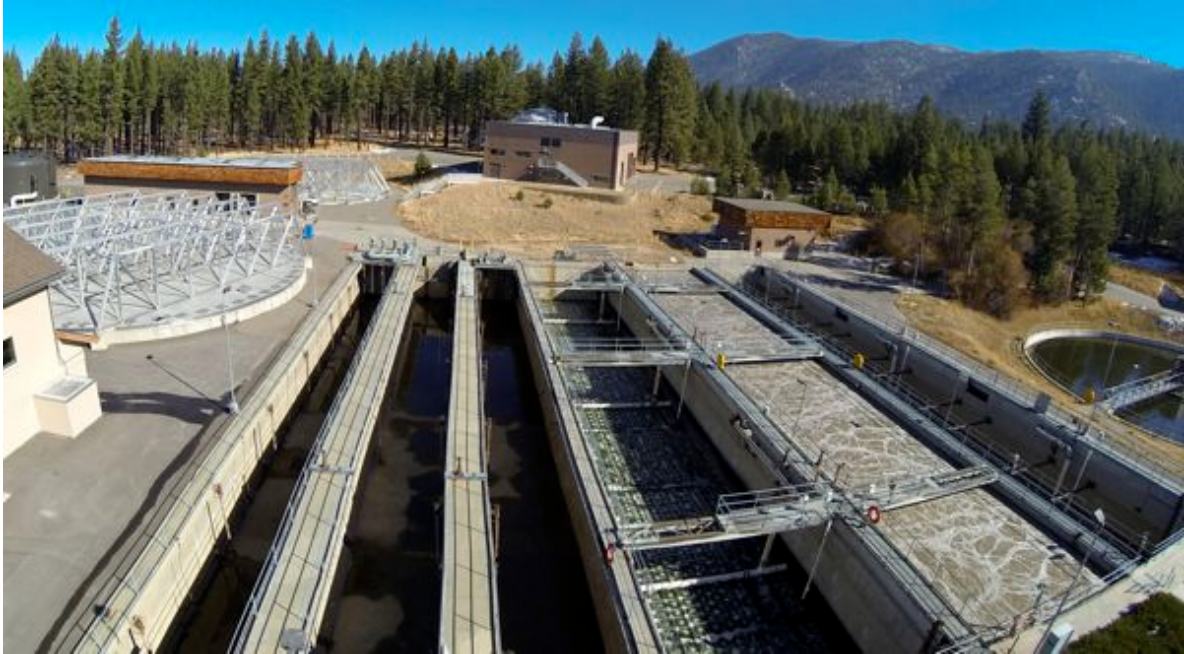
The aeration basin at South Tahoe Public Utility District. Photos/Ross Johnson

“The aeration basins are a critical part of the biological process at the treatment plant,” Sciuto said. “It’s almost like you see bubbling chocolate milk. It’s pretty uniform when you look at the surface of the water. If there is an area with less bubbles, there is probably a failure in the air pipe.”

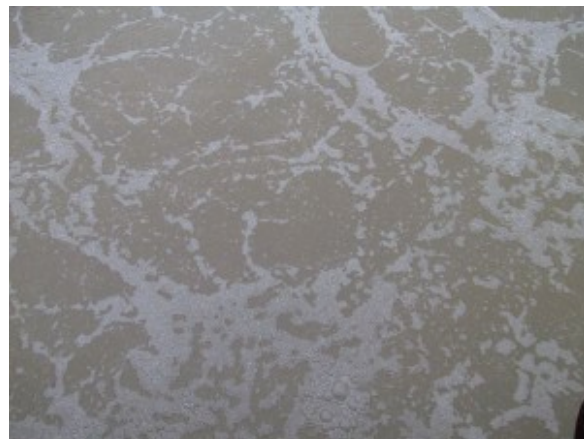
Activated sludge at the sewer plant.
