STPUD tested as it keeps water flowing during fire

Angora Fire --
5 years later

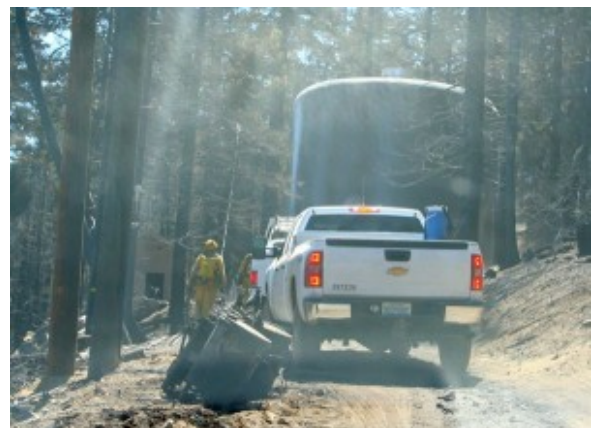
South Tahoe PUD crews on June 25, 2007, check on the Boulder Mountain water

storage tank. Photos/STPUD
