# New Upper Truckee River channel being tested

By Kathryn Reed

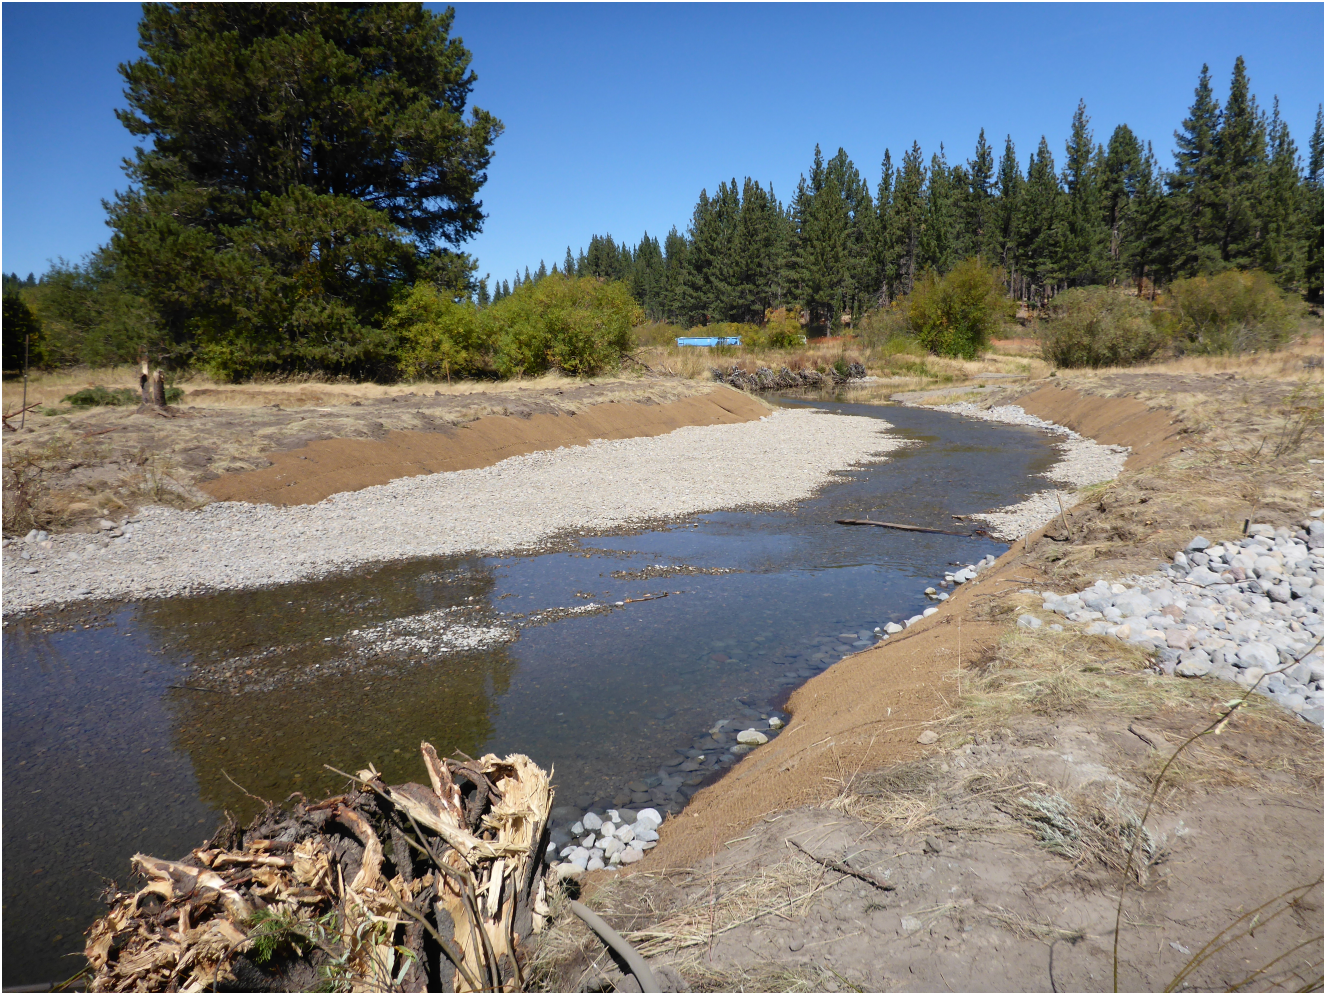
This is a view of the northern tie-in of the new channel of the Upper Truckee River in August 2016 after construction was completed. Photo/USFS

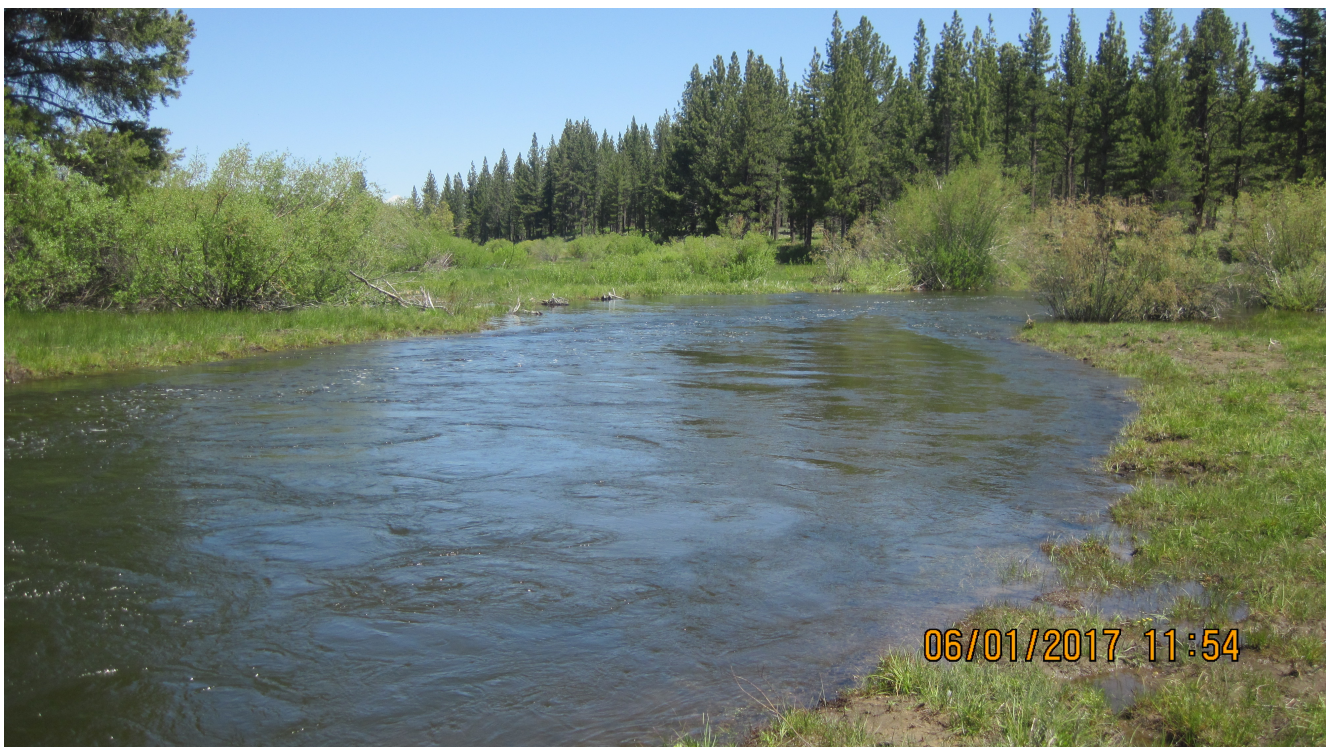
This is what the new channel of the Upper Truckee River looks like now from nearly the same spot as the above photo. Photo/USFS

Last summer the last 1,000 feet of the 7,340-foot channel was built. What is known is that between 50 and 100 feet of bank in that section has eroded. Rock armoring will be put there this construction season to stabilize the area. In some spots the vegetation did not survive, so that will be replanted as well.
