NDOT essentially rebuilding slope above Hwy. 50

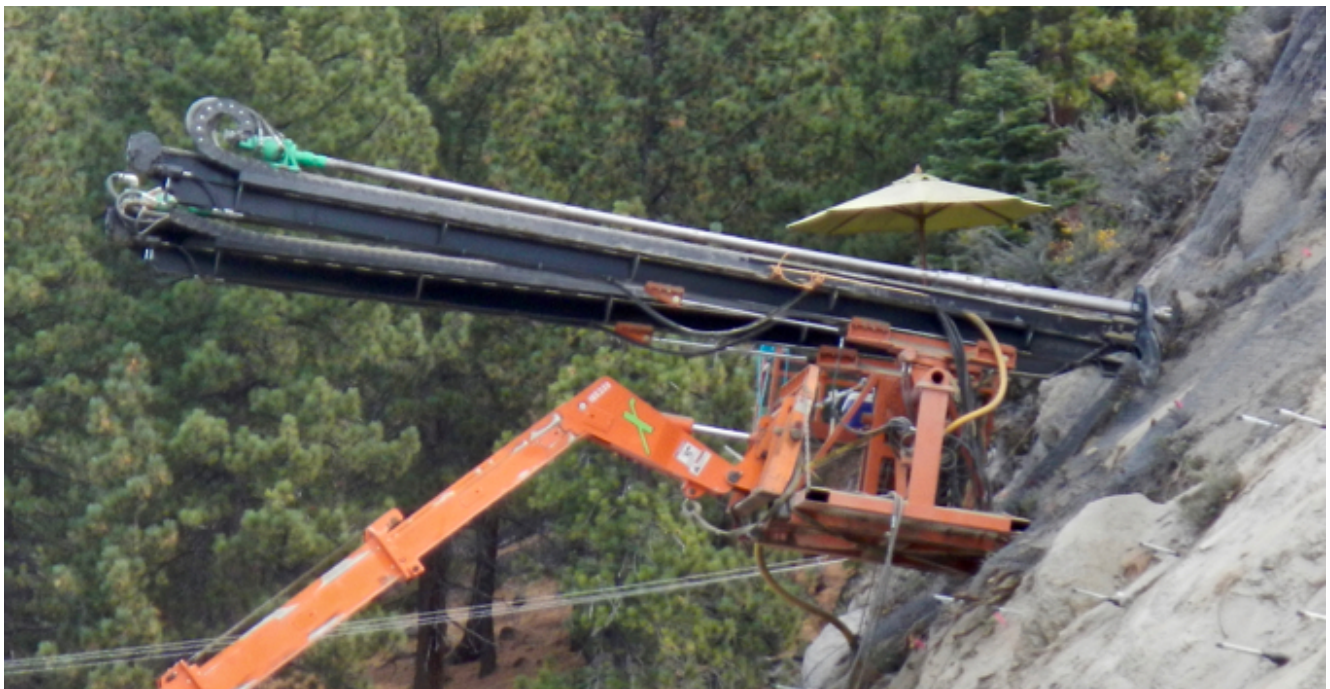
The drill used to bore 20-foot holes into the hillside that will be filled with concrete as a stabilizer. Photo/Kathryn Reed

Six-inch-wide holes have been drilled 20-feet-deep into what was described as good soil, and granite so it will be stable. They are spaced 5 feet apart in height and width in a grid pattern. They are filled to become the anchors. They are encapsulated in cement grout, with triple corrosion protection.
