# NDOT essentially rebuilding slope above Hwy. 50

**By Kathryn Reed**

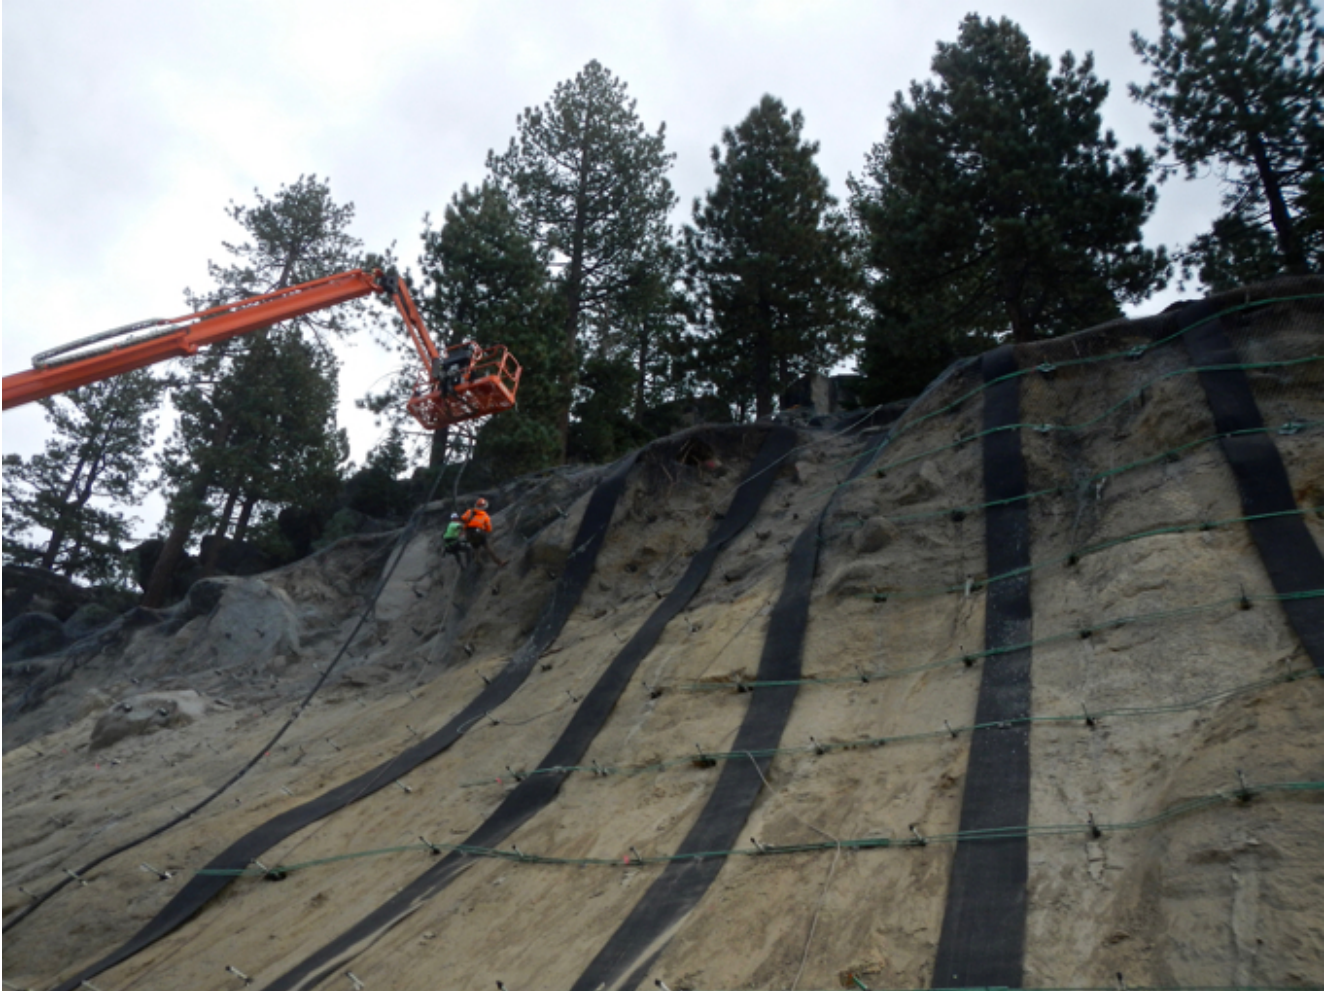
Men in climbing harnesses secure a wire mesh to the hillside above Highway 50 near Logan Shoals. Photo/Kathryn Reed

To essentially rebuild the slope requires men to be in climbing harnesses eight hours a day. They dangle above the asphalt grouting the holes.

Wire mesh is draped over the surface to help hold any loose rocks. It's then connected to the steel rods.

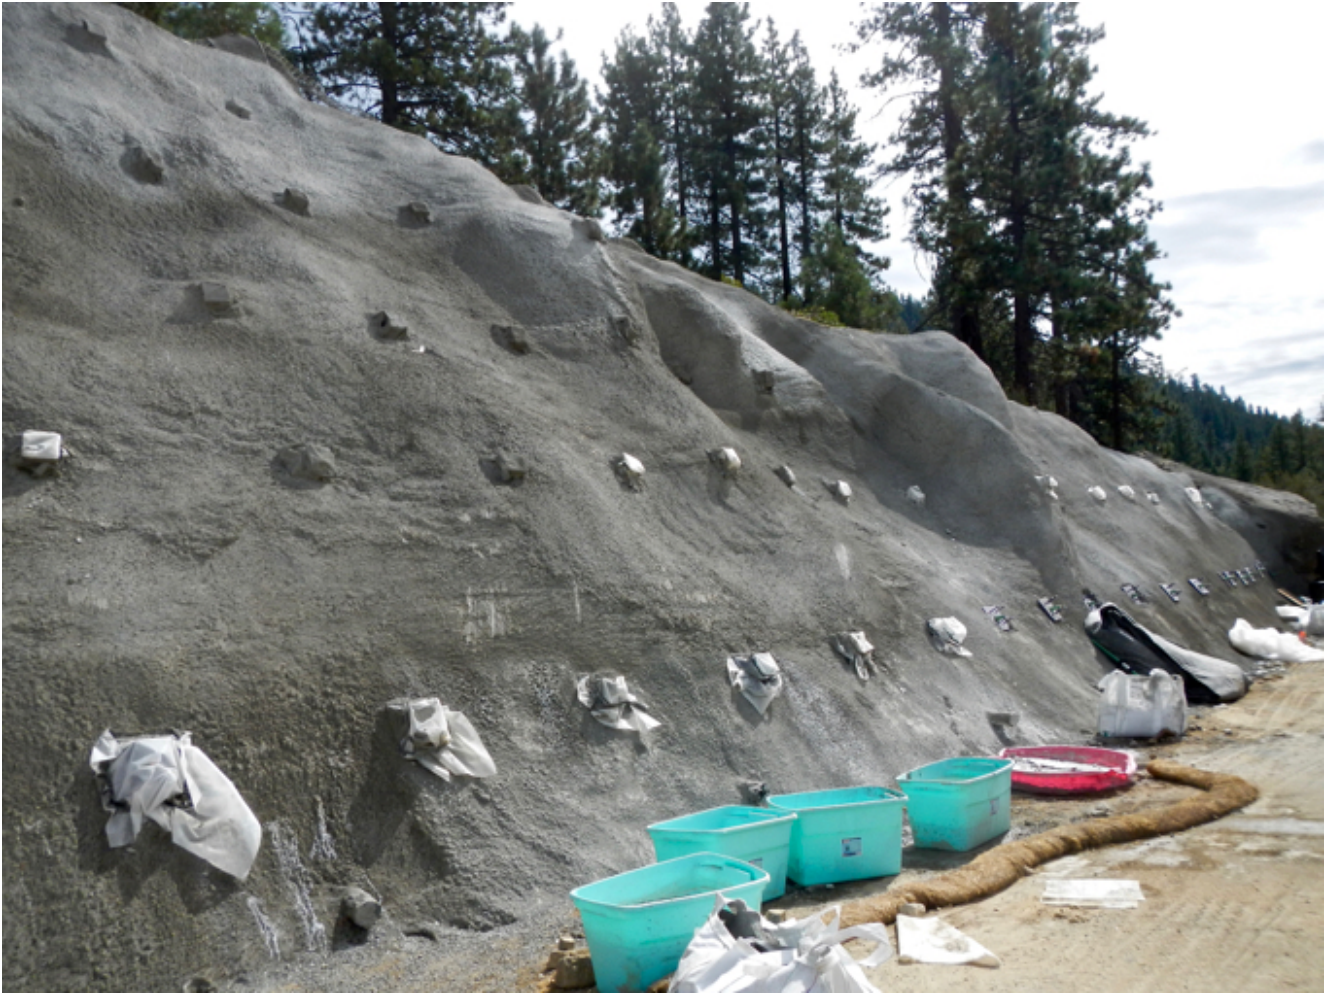
A section of the hillside with the 4-inch concrete spray and limited contouring. Photo/Kathryn Reed

By the time it's finished, the goal is the average motorist won't know that the hillside has essentially been rebuilt. Concrete will be contoured to look like natural Sierra granite boulders. "Cracks" will be added to resemble authentic fissures. The stain will also be slightly varied to complement Mother Nature.

Shotcrete has already been blown onto a section on the west end of the construction site. This is the 4-inch layer. Anchors protrude from this layer of concrete. On top another 12-inches of shotcrete will be sprayed on. This is similar to what took place on Cave Rock recently when NDOT contractors secured that rock structure.

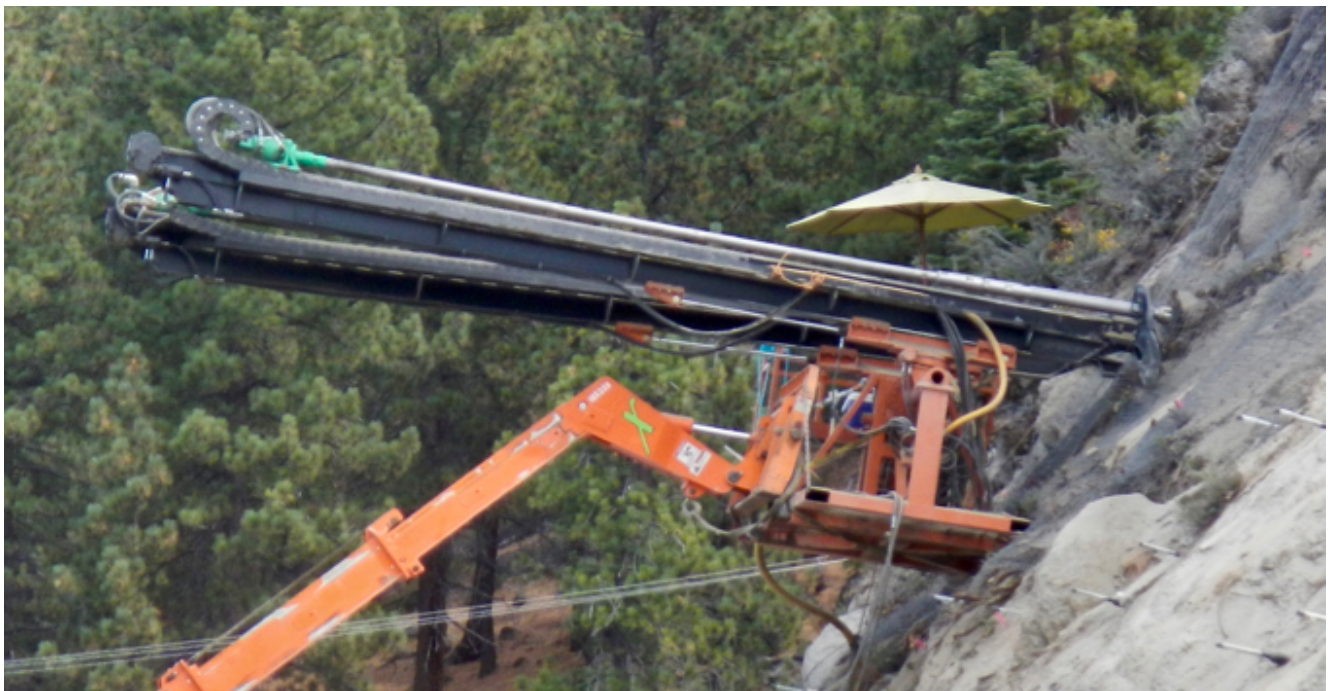
The drill used to bore 20-foot holes into the hillside that will be filled with concrete as a stabilizer. Photo/Kathryn Reed

Six-inch-wide holes have been drilled 20-feet-deep into what was described as good soil, and granite so it will be stable. They are spaced 5 feet apart in height and width in a grid pattern. They are filled to become the anchors. They are encapsulated in cement grout, with triple corrosion protection.
